Big Blocks Replace Old Wooden Railroad Tie Walls

Harvey's Lake, Pennsylvania, USA

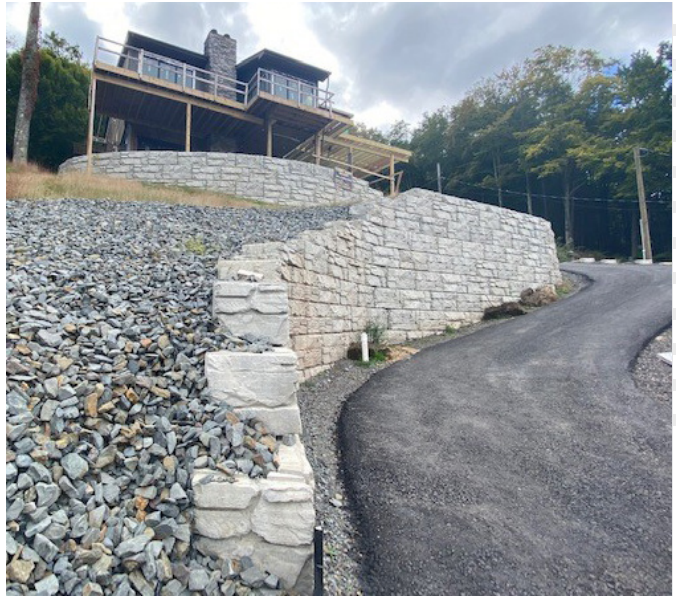
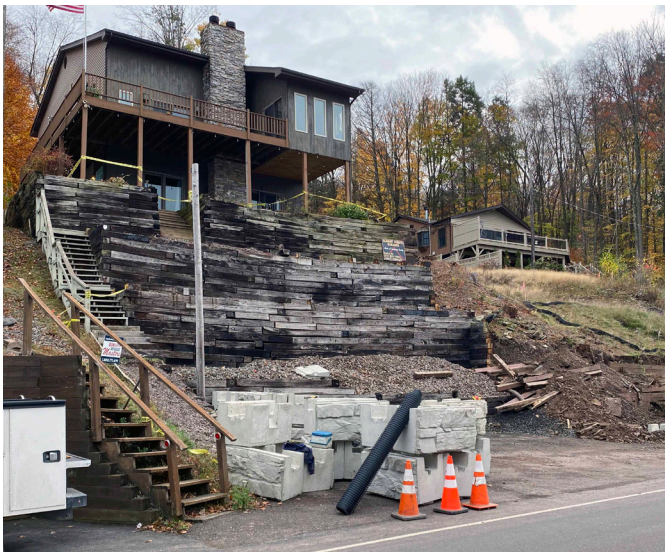
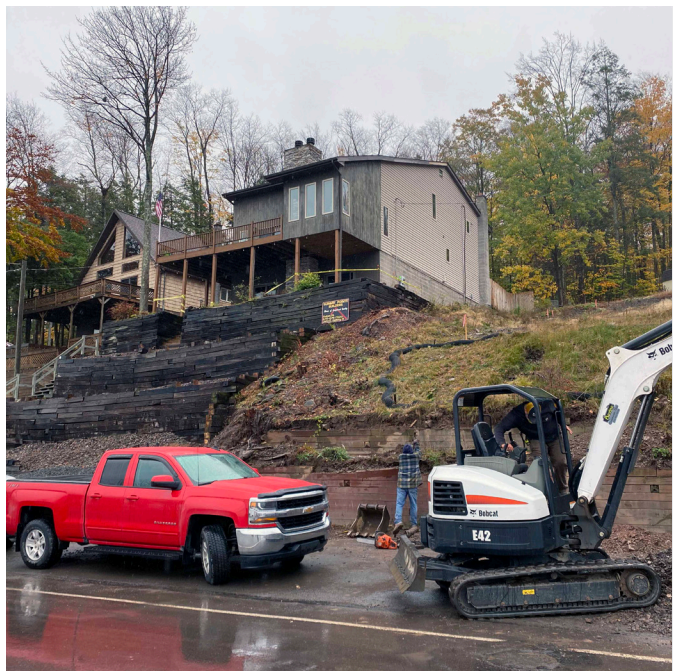
For 20 years, homeowners of the lakeside property accessed their home by parking roadside and hiking over 50 steps uphill to their door. Aged railroad tie walls stretched across the front of the property, built to support the house and land above. Unfortunately, the quality of these wooden materials rapidly declines over short lifespans, requiring frequent maintenance and costly repairs. Despite challenges encountered throughout this project, MagnumStone's versatile blocks and gravity extenders proved vital to the property's major overhaul.

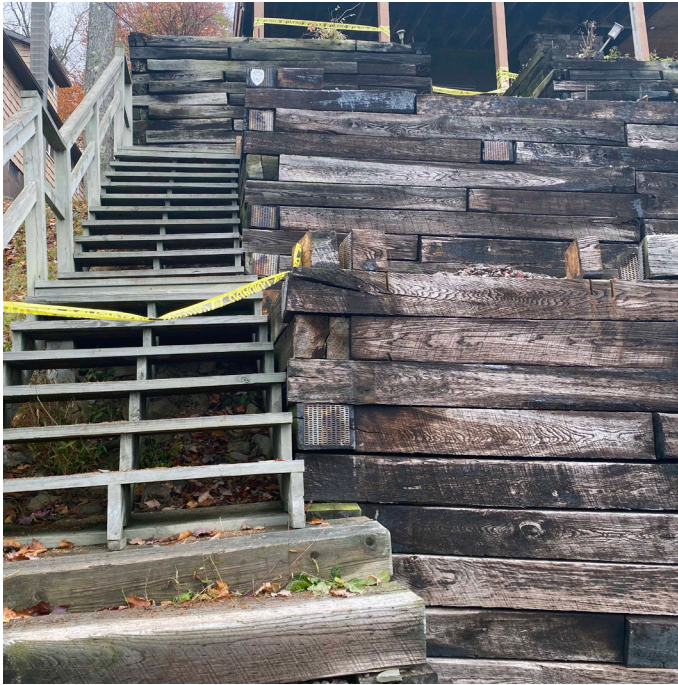
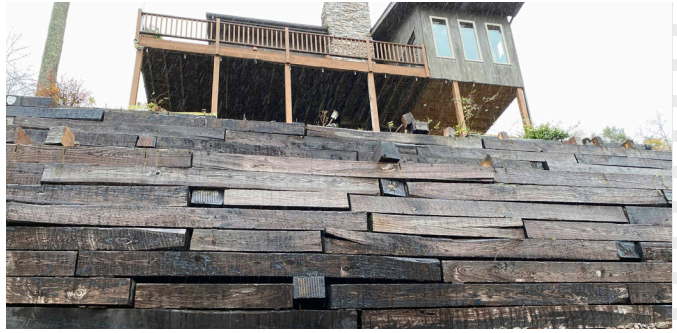
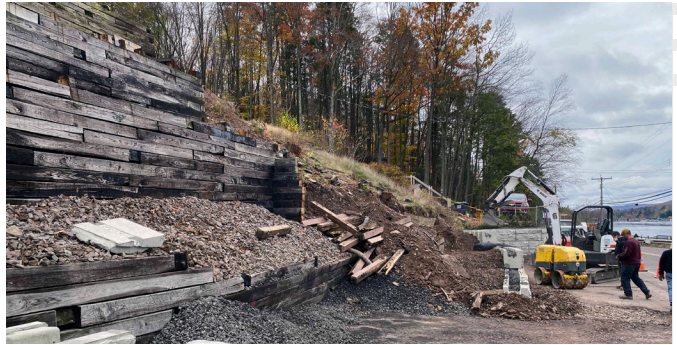
Water damage is globally recognized as the leading cause of most retaining wall failures, especially wooden retaining walls. This is a major safety hazard, frequently exemplified by boards splitting apart, wood becoming disjointed or negative leans appearing. These are obvious warning signs of an

impending wall failure that has serious potential to collapse. Several of these characteristics could visibly be seen at the lakeside property prior to this MagnumStone installation.

Other common issues worth noting for railroad tie walls are fractures or splintering of wood which compromise their strength. These are caused by the railroad ties themselves splitting and damaging the wood. Treated wood preservatives can also contain harmful chemicals for soils, pets and children.

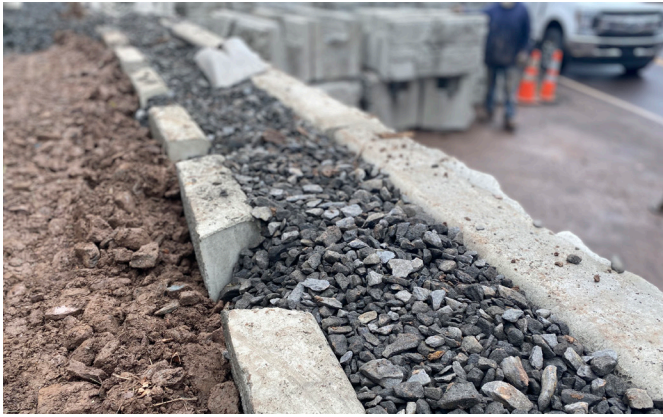
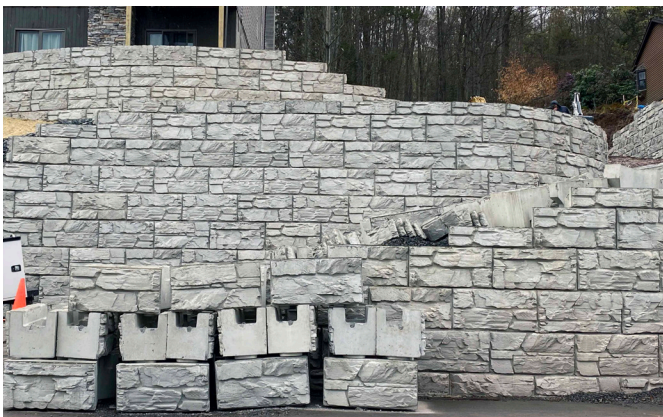
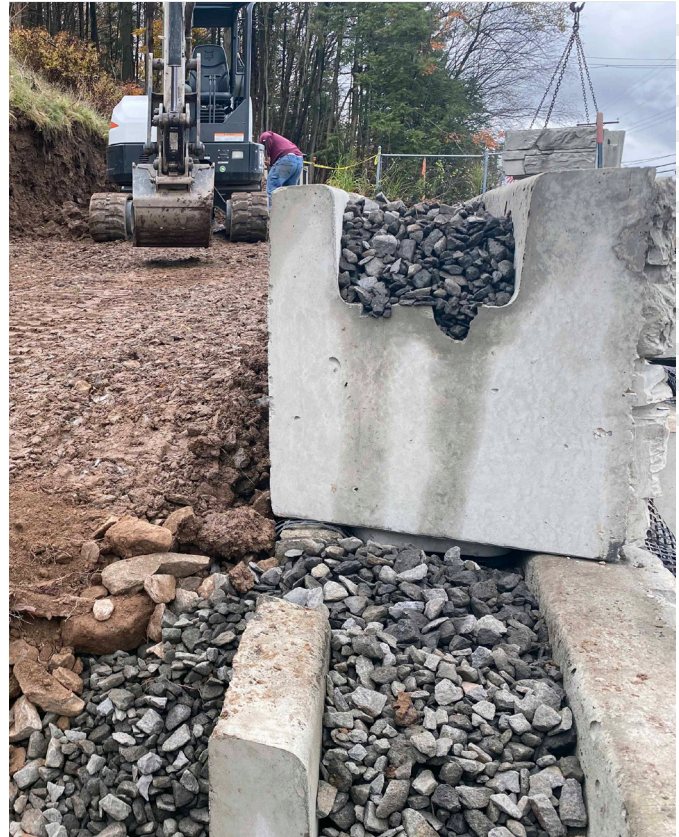
In 2019, general contractor Summit Pointe Builders began searching for retaining wall solutions to fit this complex residential application. With no existing driveway on the property, the homeowners wanted to build a driveway that provides access to their house atop the hillside. This meant replacing the failing terraced wall structures and steps lining the steep hillside. Site conditions were a concern and like most lake properties, space was extremely limited.

Unfortunately, the existing railroad tie structures were never designed to retain such steep slopes and pressures of the house above. Summit Pointe Builders were skeptical of using a traditional

As the excavation and removal of the original wall structures began, the complicated project met its first obstacles. Loose fill behind the walls began to fall, threatening to undermine the house foundation. Summit Pointe worked diligently with Race Engineering Assoc. LLC on a plan to protect and stabilize the fragile land. This culminated in new retaining wall designs, including a blend of gravity, geogrid and hybrid retaining walls throughout the property.

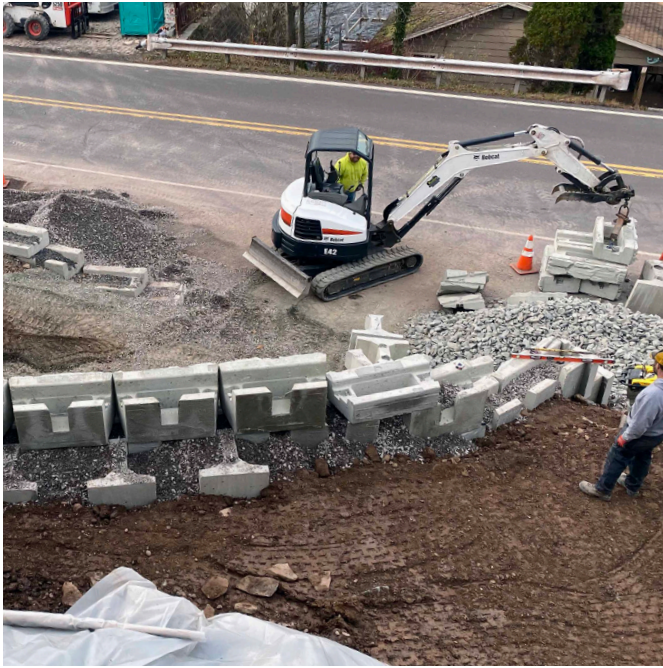
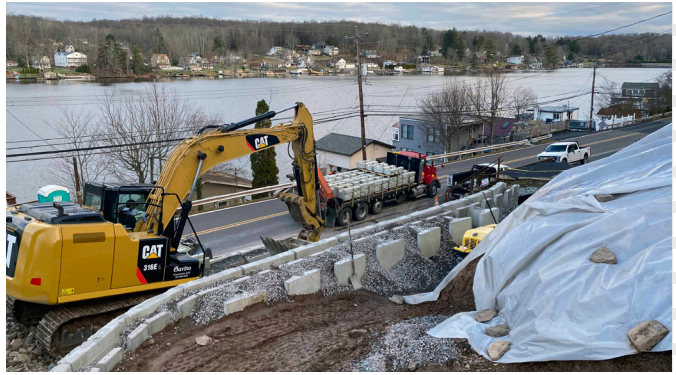
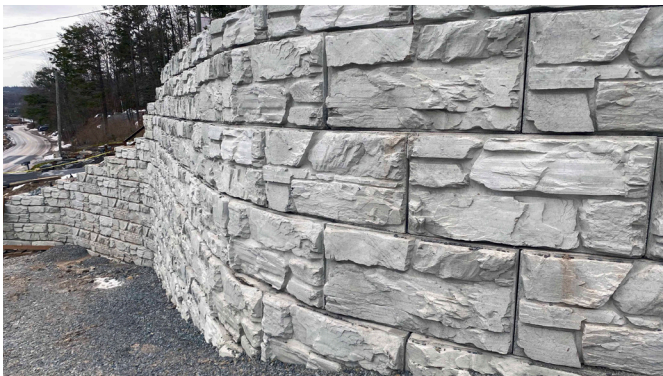
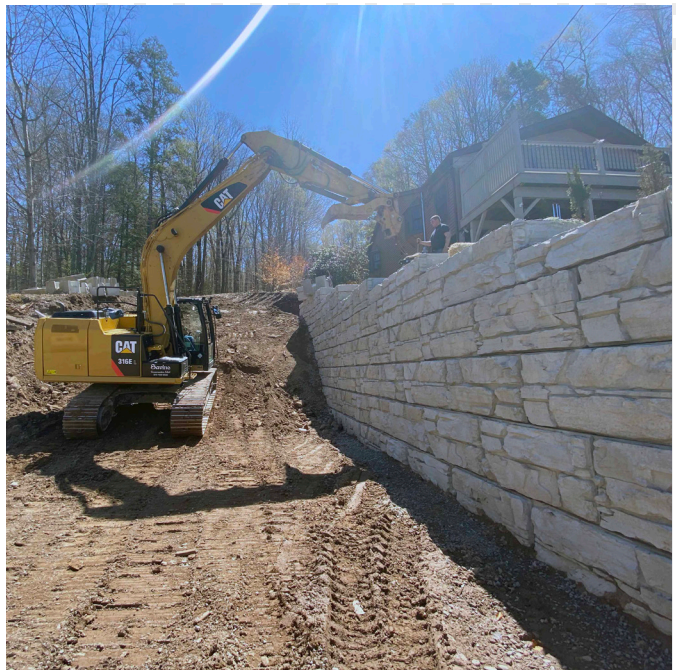
Gravity retaining wall designs were used near the house foundation and property lines because they excel in tight spaces with limited excavation area. They rely on their weight to effectively retain soil and resist load pressures. These gravity walls limit land disturbance and maximize valuable space by enabling construction closer to structures and land perimeters. Gravity retaining walls were therefore installed in these critical areas to minimize the excavation footprint.

MagnumStone's one-of-a-kind short and long gravity retaining wall extenders were vital to strengthening these retaining walls from an engineering standpoint. The units attach behind standard MagnumStone blocks in various increments to provide more flexibility with retaining wall designs. As the only retaining wall system on the market with 2 ft. and 4 ft. length gravity extenders, MagnumStone gravity walls require less intrusive excavation areas. This made reinforcing and strengthening the backfill a much safer, simpler process.

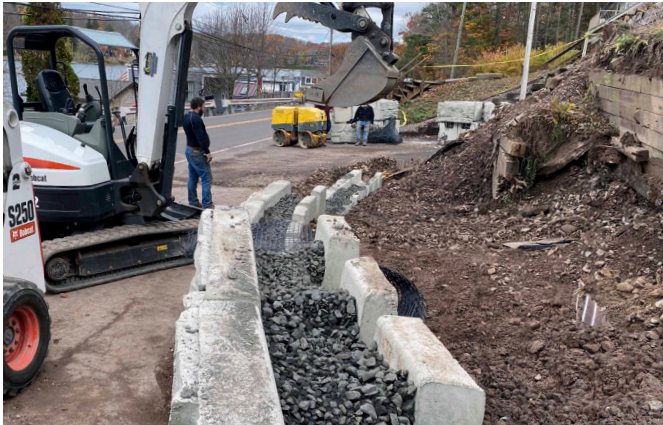
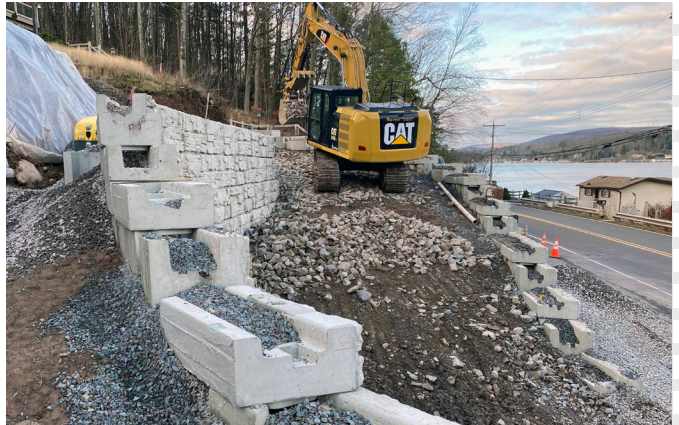
MagnumStone's geogrid retaining walls use their mass and geogrid reinforcement to support active pressures from above and behind the wall. Of the property's four MagnumStone retaining walls, only the wall closest to the road is fully reinforced with geogrid. The retaining wall along the other side of the driveway is only partially reinforced with geogrid. These type of retaining walls require plenty of excavation space and stable soil behind them.

Due to the instability of loose fill behind the railroad tie walls, geogrid retaining walls were deemed unviable for a portion of the retaining wall along the upper side of the driveway. Without ample space to lay geogrid reinforcement behind that upper wall, further digging risked potential damage to the structures above. Luckily, MagnumStone's versatile design opened more creative design options for advanced engineering solutions by Race Engineering Assoc. LLC. To prevent risky earthwork, a hybrid gravity and geogrid retaining wall was planned and

Given the unstable soils at the curve in the driveway, the hybrid retaining wall allowed for optimal performance. The portion of the upper wall which meets the roadway is reinforced with geogrid. As the driveway creeps further up the slope, it converts to a gravity retaining wall securely fortified by gravity extenders. This allows for structurally sound retaining walls throughout the full length of the upper driveway's wall, albeit with a hybrid twist. MagnumStone's big blocks are the most versatile on the market, which

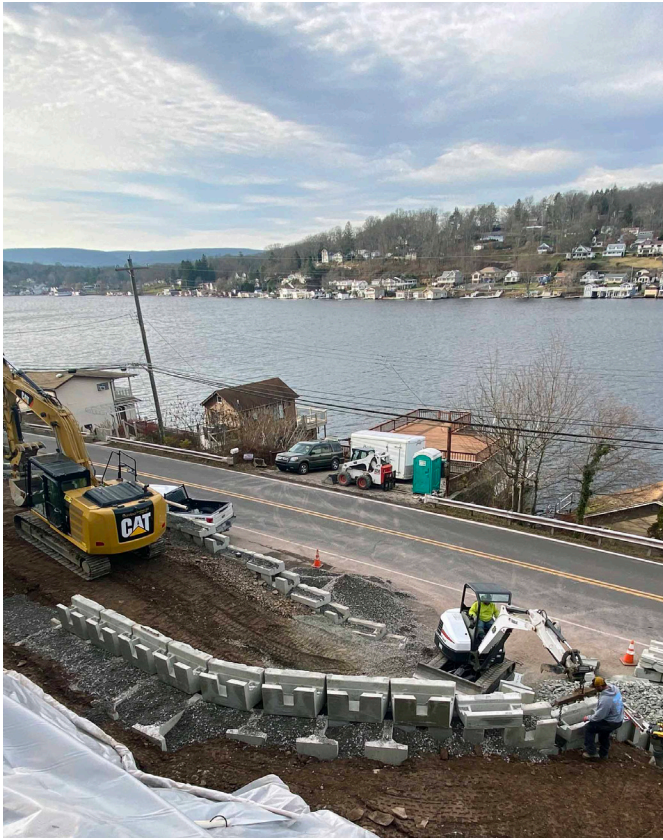
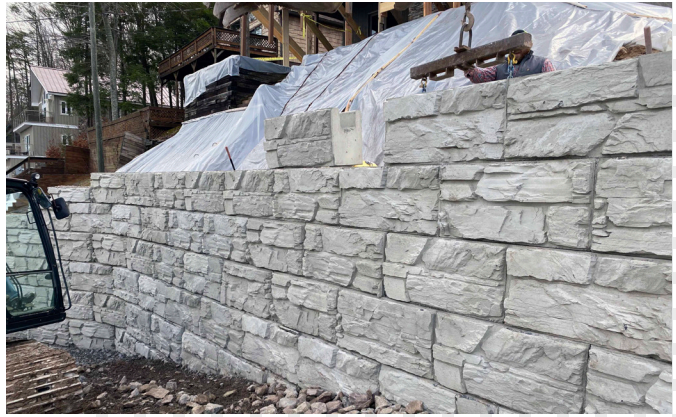
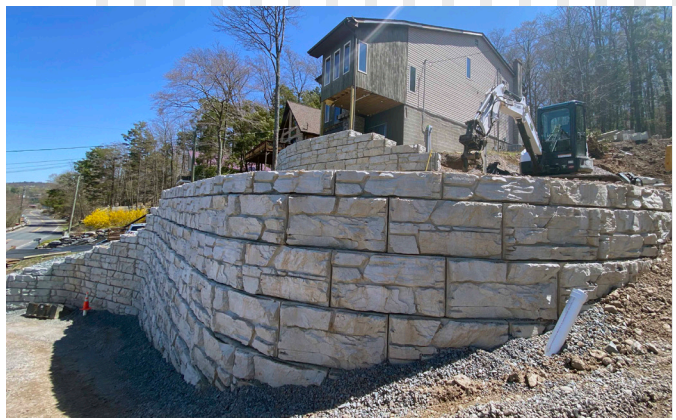
Arguably the most remarkable aspect of this project is that it only took a team of two to complete. That's right, Savino Construction accomplished most of this terraced retaining wall masterpiece with just two people and a small excavator and skid steer. A larger excavator was also used for parts of the project that required more height. MagnumStone's lightweight big blocks each cover 8 sq. ft. (0.74 sq. m.) which make installations a breeze for any size retaining wall. While traditional retaining walls typically require several people and large machinery to move the blocks, MagnumStone only requires small teams and small equipment to perform installations.

While one person operates the machinery, the other easily attached blocks to the equipment and guides the blocks into place. This is reflected in project savings, as MagnumStone significantly reduces labor costs and extensive rental expenses for large machinery.

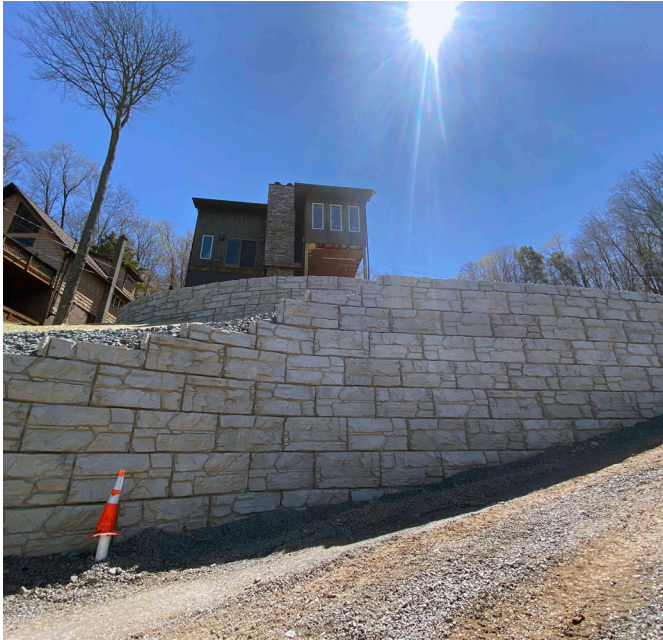
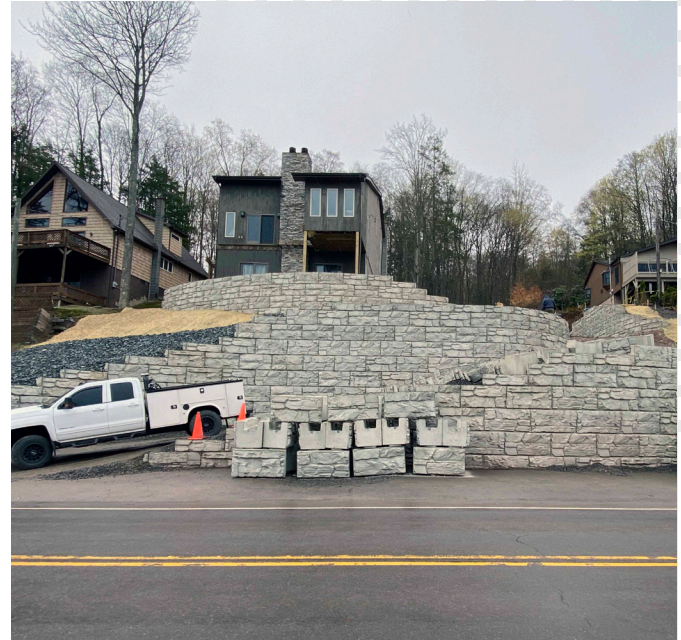
Effective performance is most important for any retaining wall; however, a beautiful property is a point of pride for landowners. That's why MagnumStone offers the most dynamic looking retaining wall facings on the market. The blocks give a professionally landscaped, natural rock appearance to boost property value, while the system provides secure, long-lasting strength.

Wooden retaining walls - including railroad tie walls - look great initially but their looks and durability degrade quickly over time. Disjointed or leaning retaining walls often reflect poorly on property owners and send the wrong message to neighbors and passersby. MagnumStone's low-maintenance, precast concrete walls present a refreshing modern look that blends in perfectly with any landscape.
